POTOMAC YARD METRORAIL STATION ENVIRONMENTAL IMPACT STATEMENT

Soils and Geological Conditions

February 2013

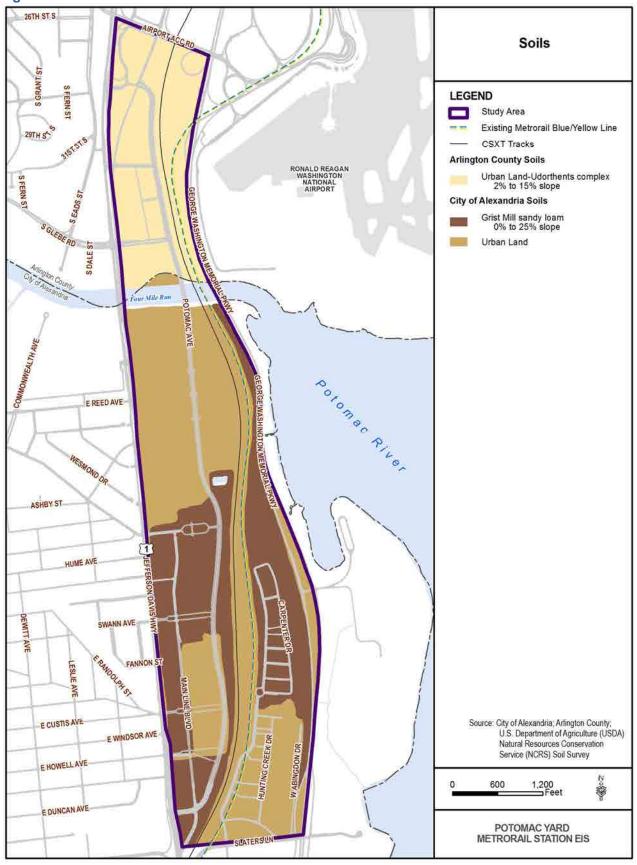
Figure 2-1: Soils

Urban land-Udorthents soils are formed when the original soils were disturbed by land-leveling, excavating, or filling. They consist of loamy and clayey soil material and varying amounts of rock fragments. Areas range from slightly compacted to severely compacted. Unvegetated areas are susceptible to severe erosion. Generally, Udorthents are found by highways, rail yards, railroad tracks, quarries, mines, large buildings, and other areas that have been excavated or filled.

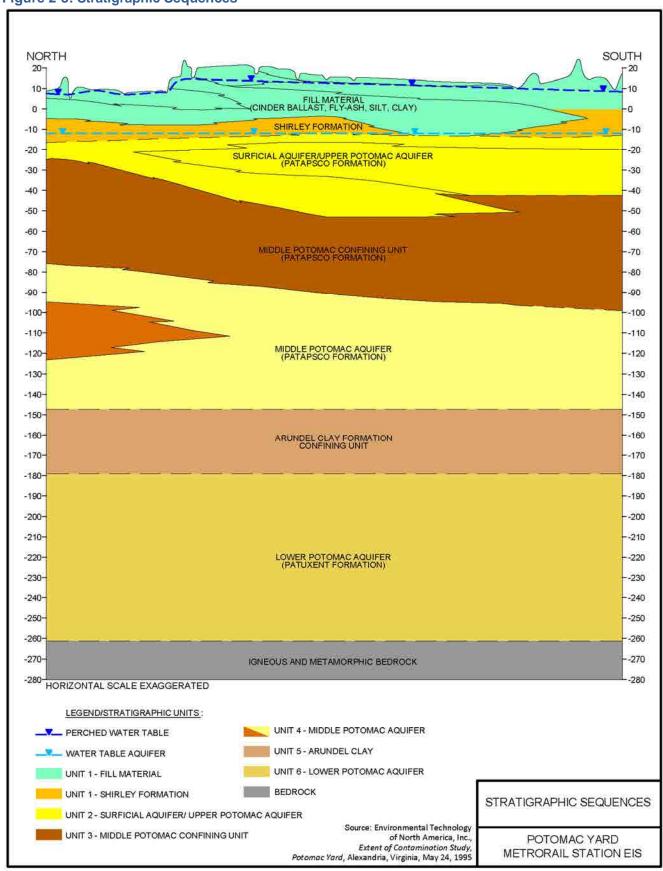
Figure 2-3: Stratigraphic Sequences

The geology of the study area was delineated from ground surface to the bedrock during previous environmental and geotechnical investigations. The stratigraphic sequence (sedimentary layers) of the study area consists of six units. In descending order, these units include: ballast-cinder material, fill material, Shirley Formation (described in the soils section), Patapsco Formation, Arundel Clay Formation, and Patuxent Formation. These sequences are depicted in **Figure 2-3** and **Appendix C**. Geological conditions described in this section begin at a depth of 80 feet bgs.

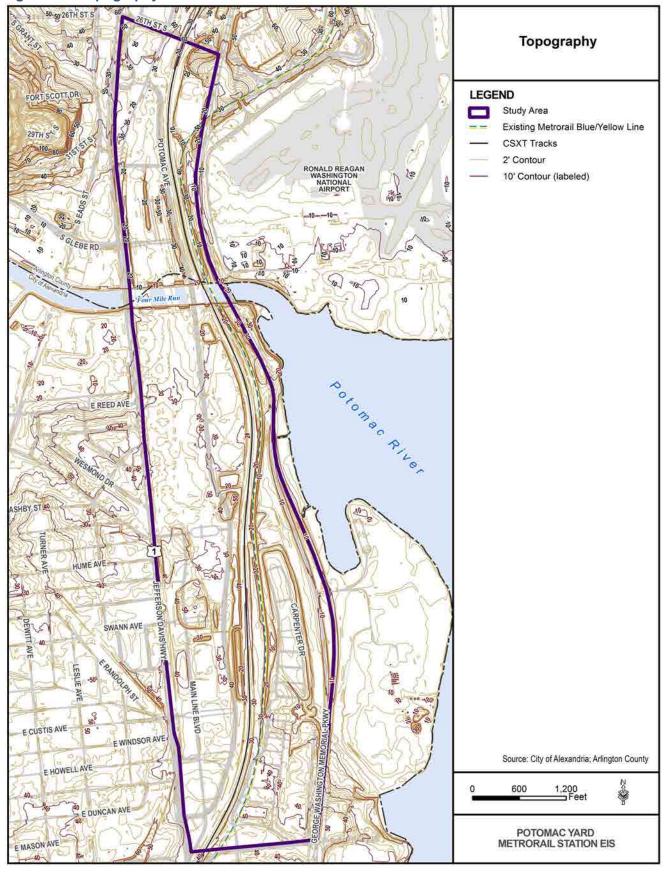
Figure 2-4: Topography

Topography is defined by USGS as "the shape and relief of the land surface." The "relief" of an area is defined as "differences in elevation" resulting from natural and man-made conditions.

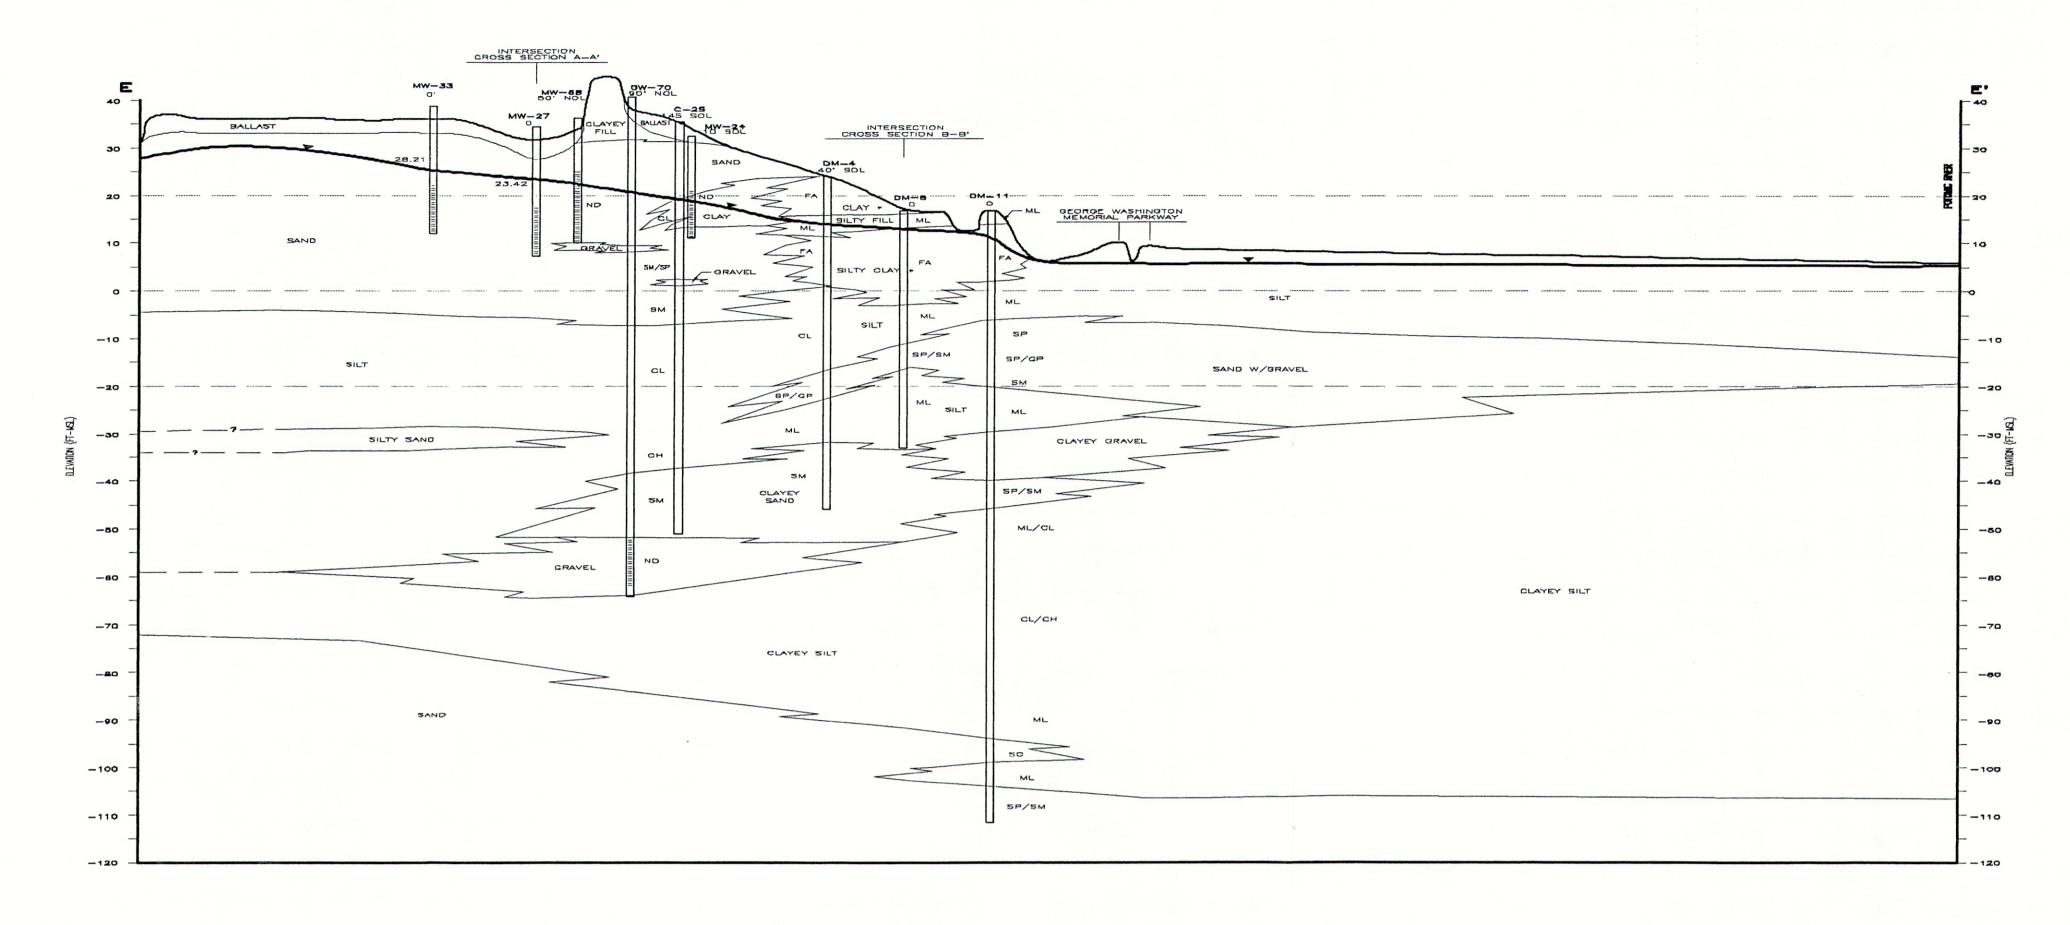
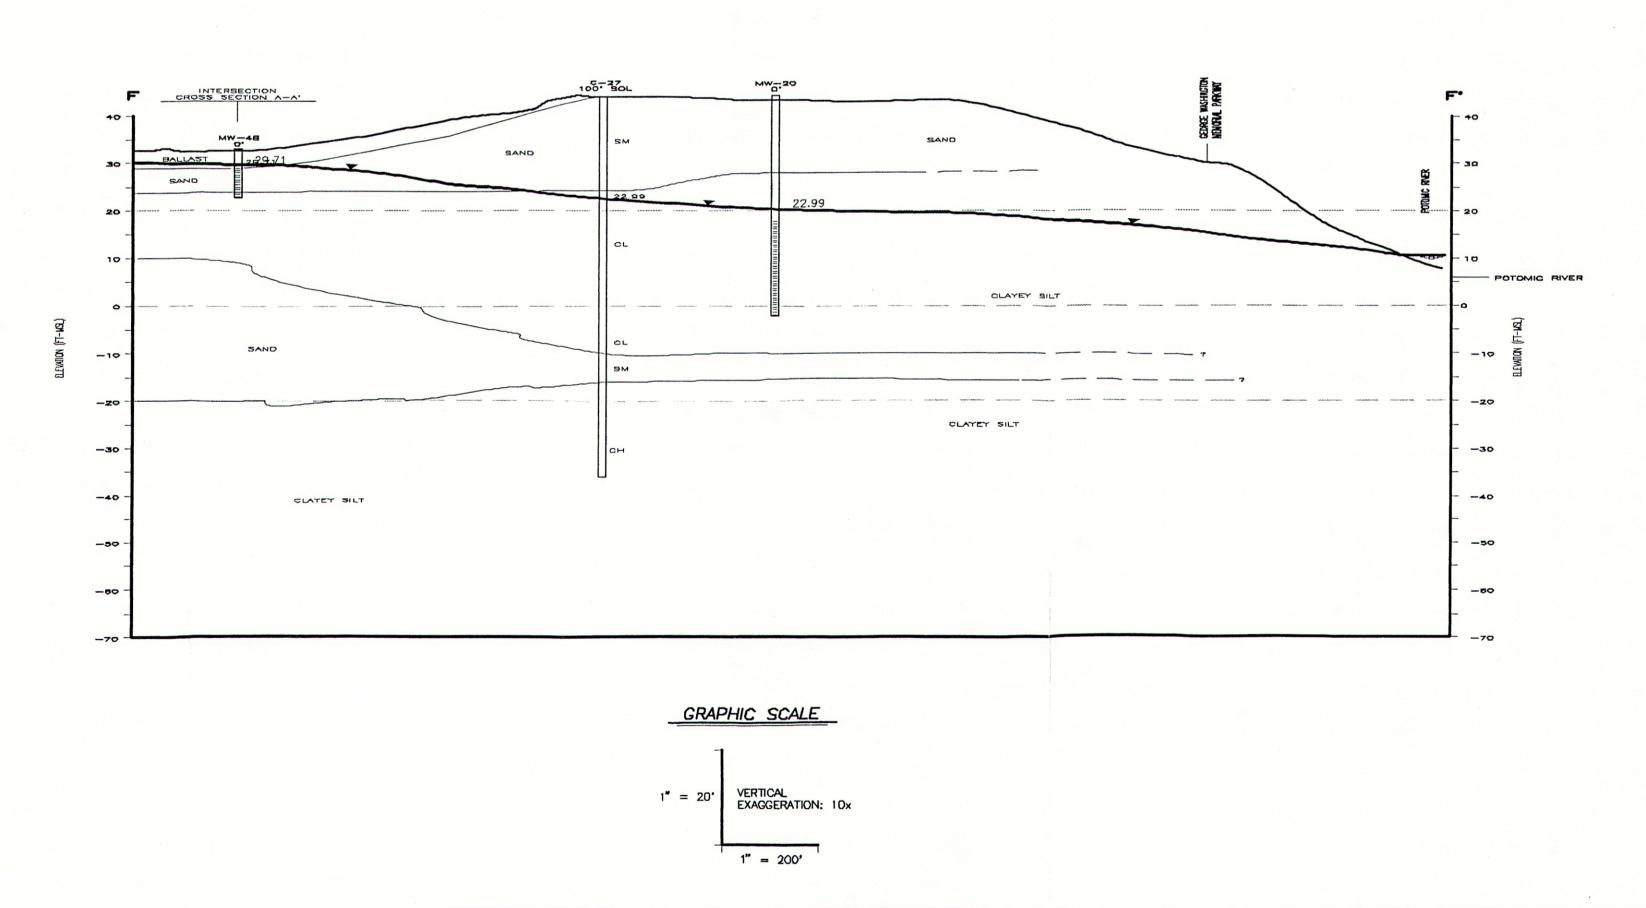
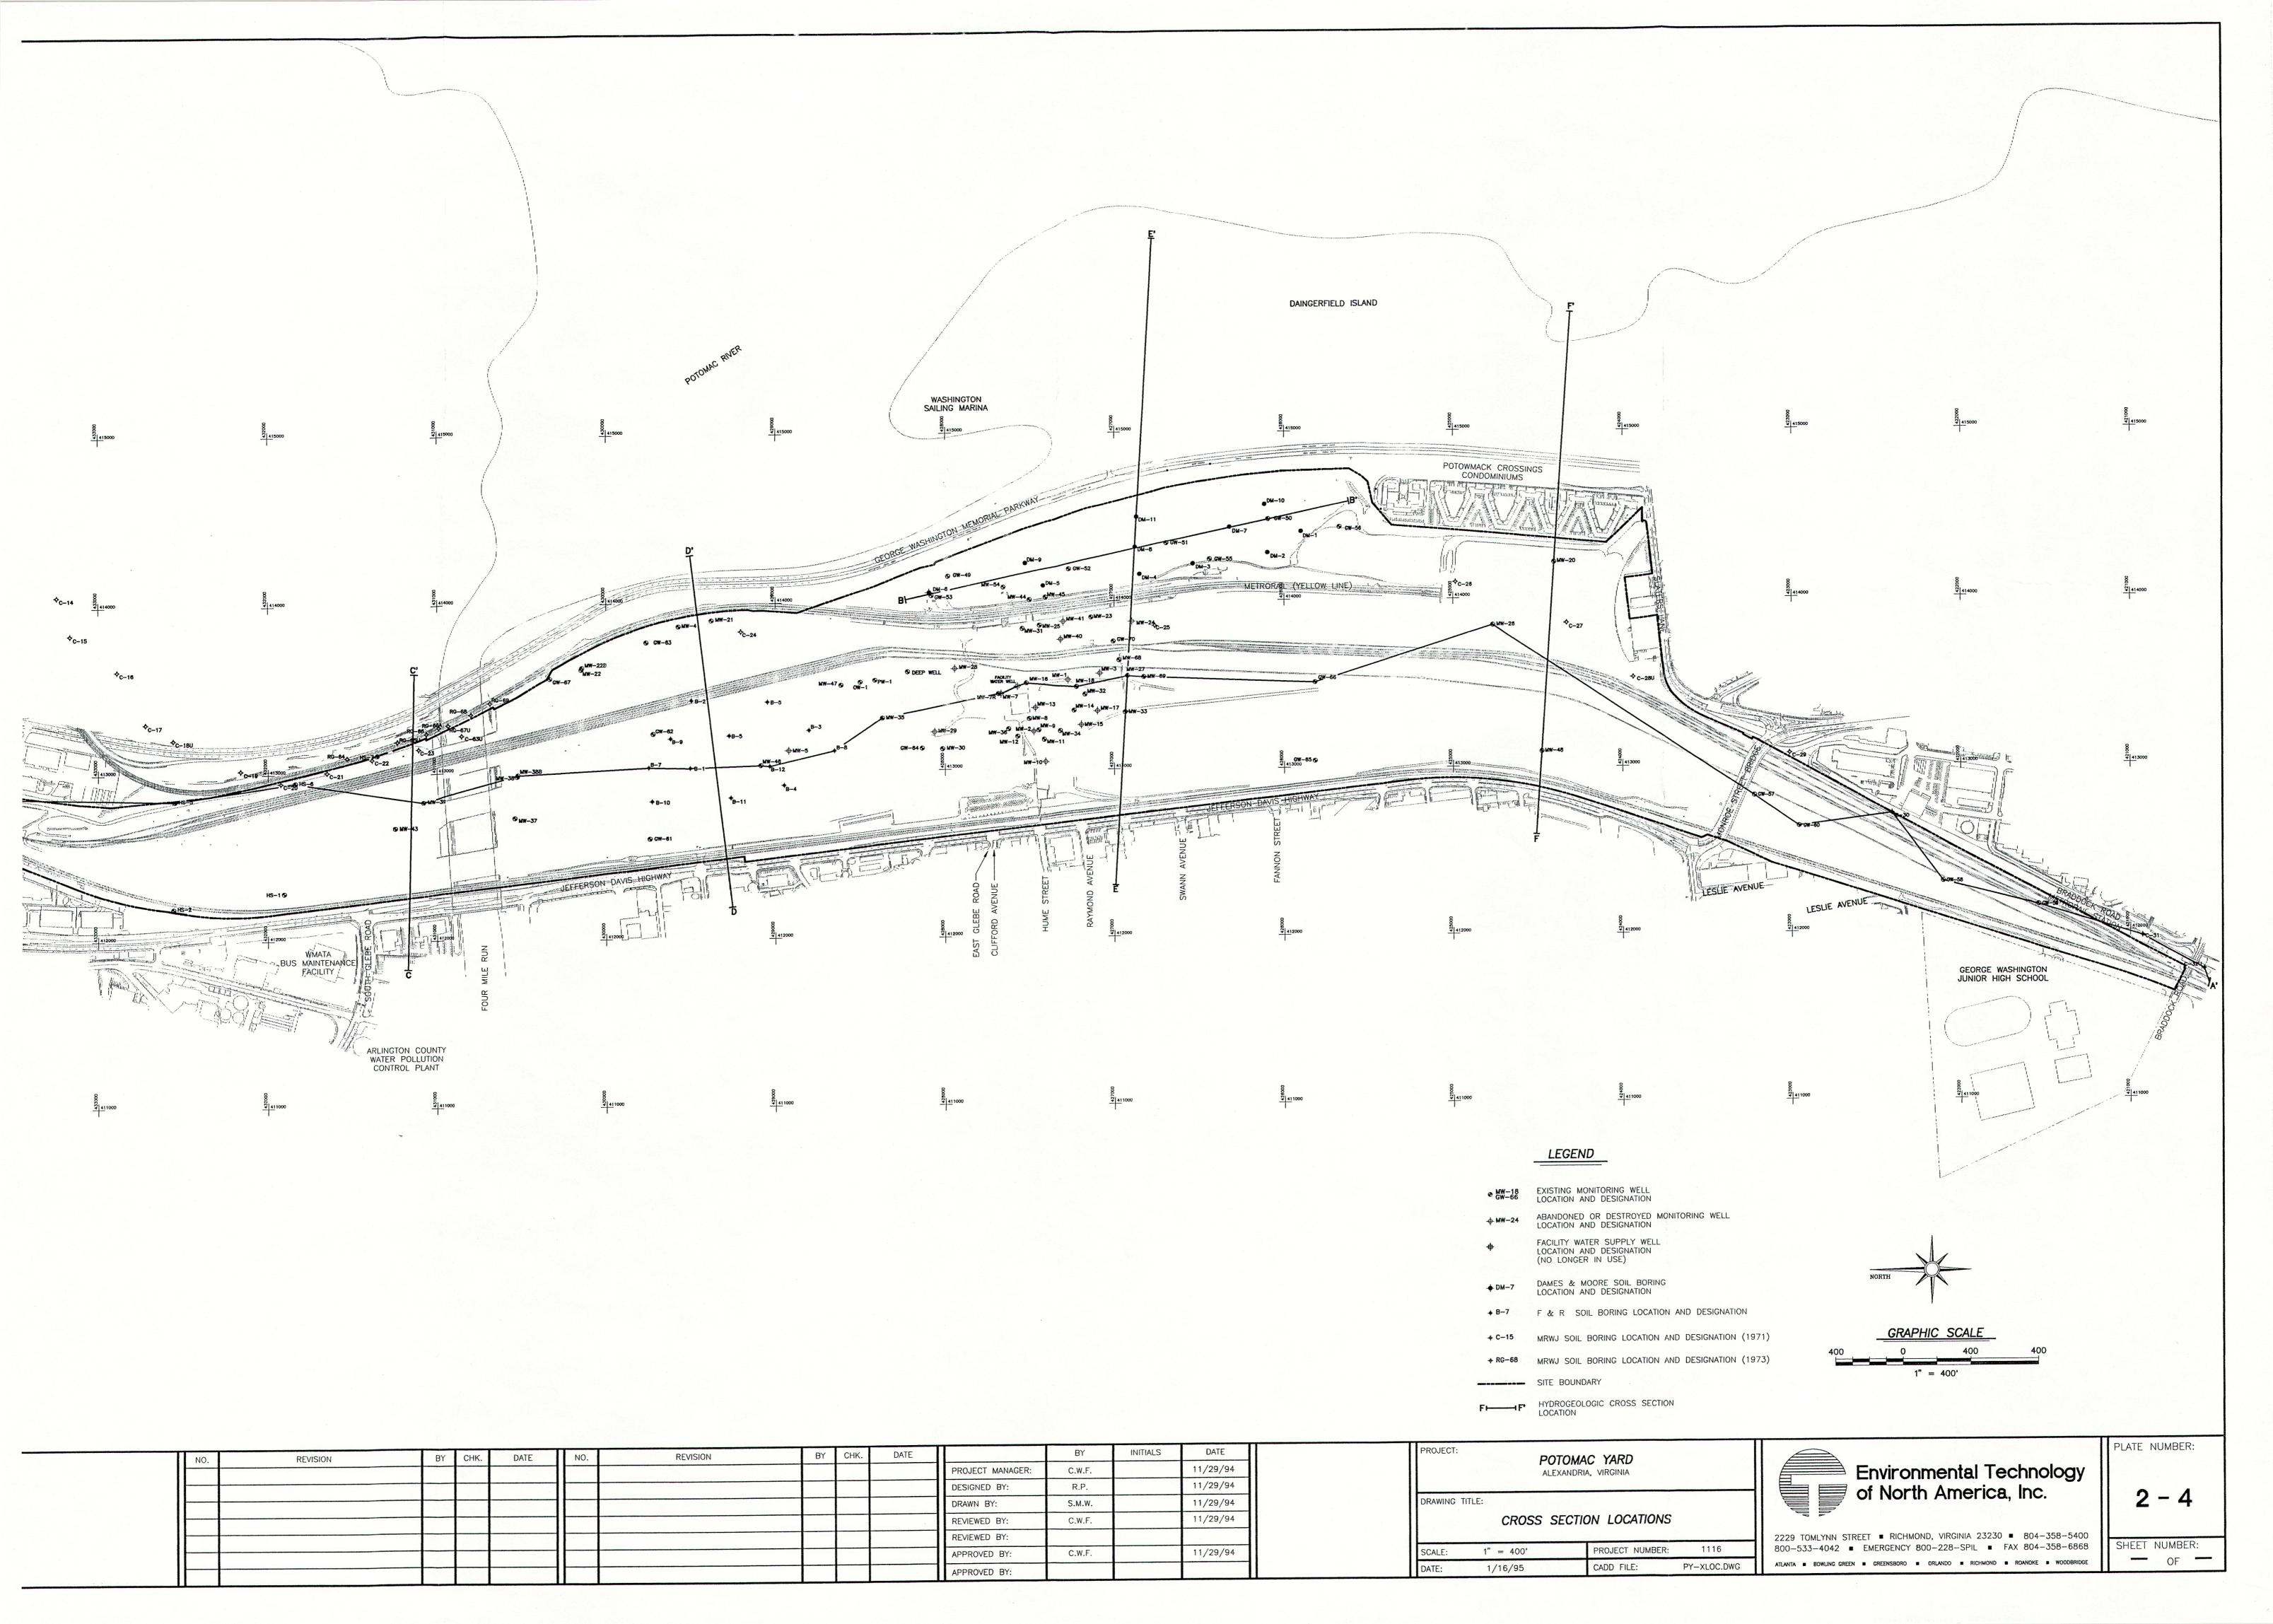
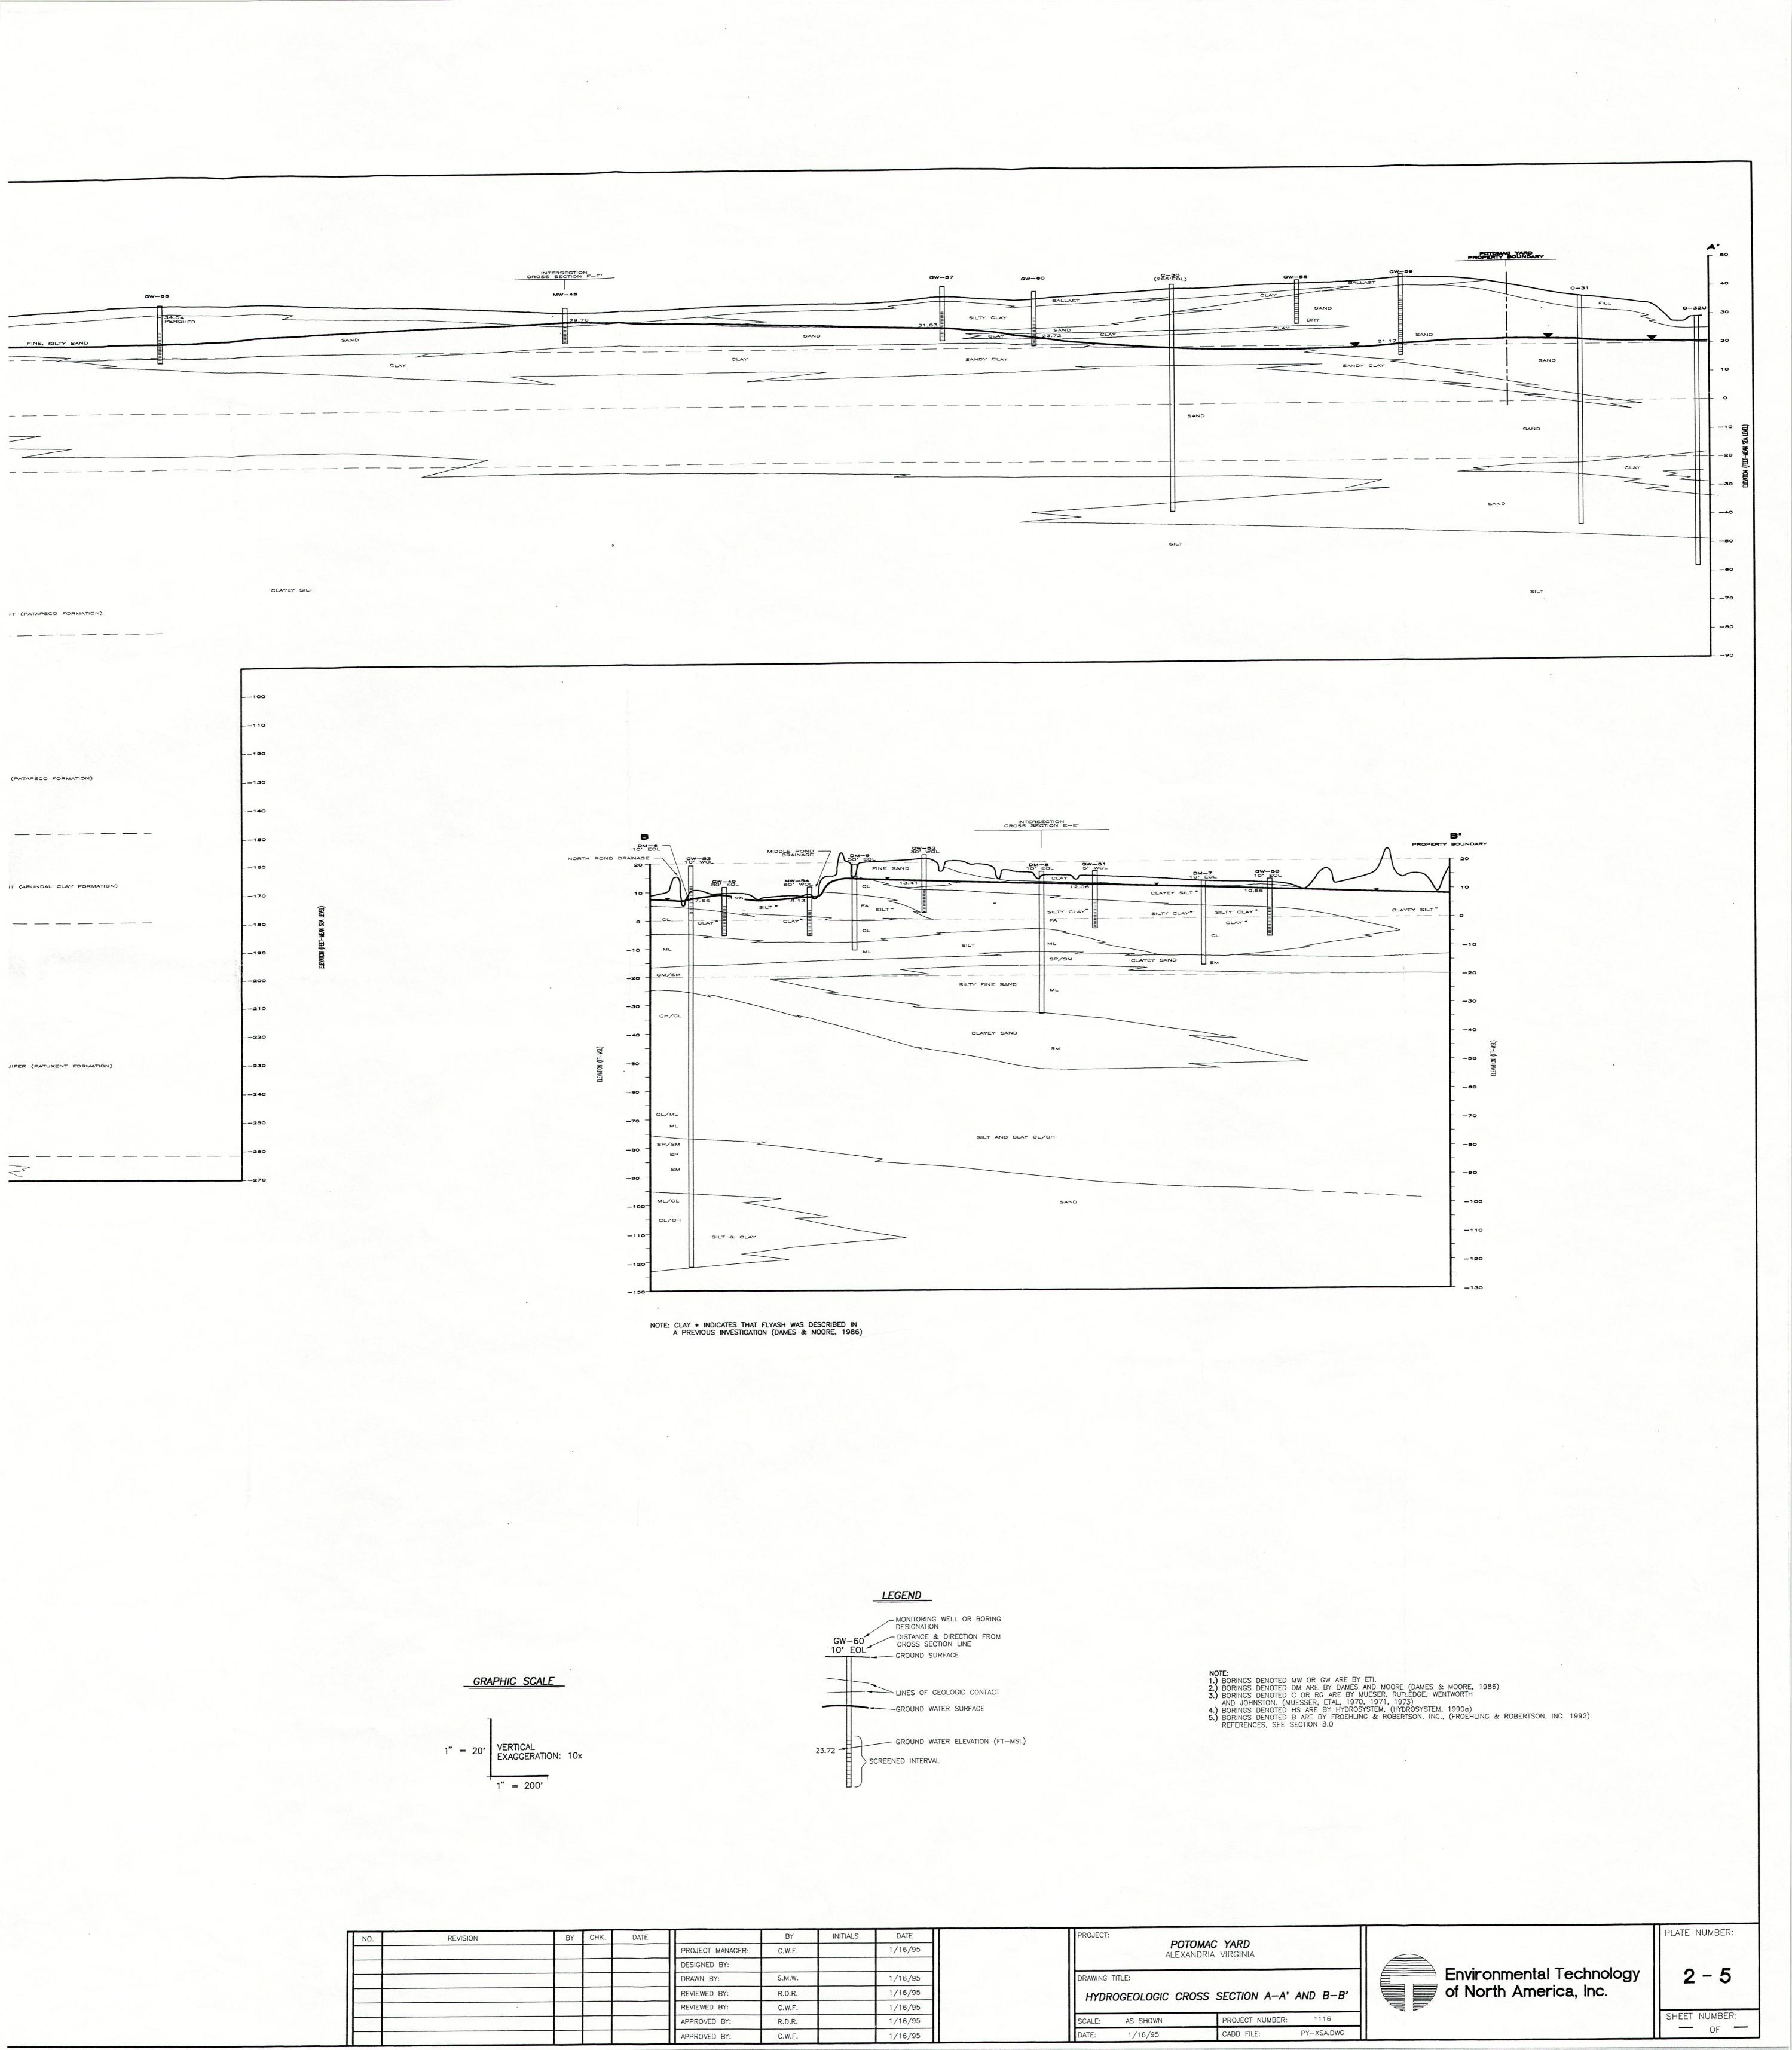
APPENDIX C: POTOMAC YARD CROSS SECTIONS (1995 EXTENT OF CONTAMINATION STUDY)

NOTE: CLAY * INDICATES THAT FLYASH WAS DESCRIBED IN A PREVIOUS INVESTIGATION (DAMES & MOORE, 1986)

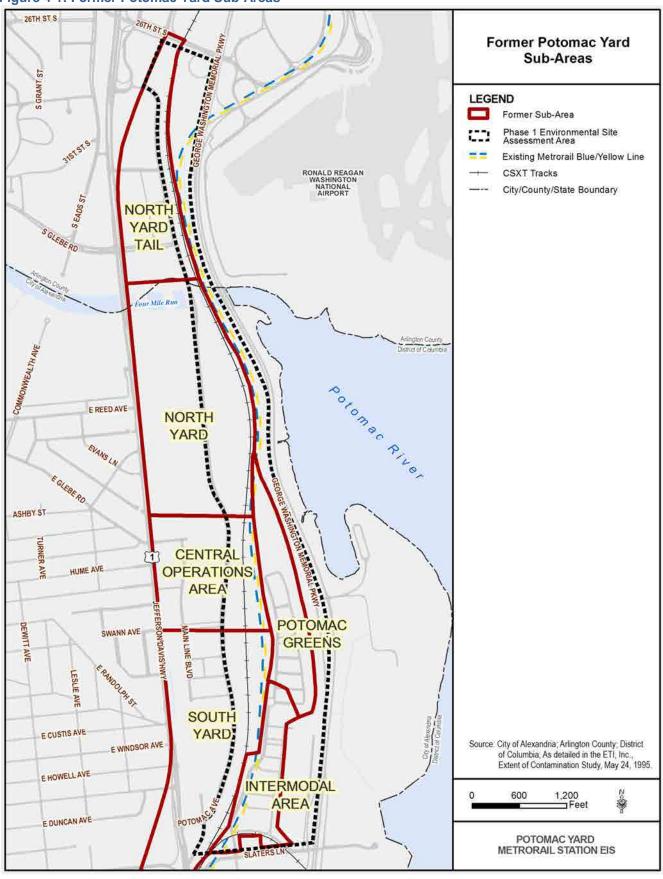
Figure 4-1: Former Potomac Yard Sub-Areas

A 105-foot locomotive turntable and roundhouse area were located at the Central Operations Area. The turntable was excavated and removed in 1994. This area was used to service, maintain, clean, and repair "yard" locomotives used on site. Just west of the main turntable, an 80-foot turntable was used until the 1930s or 1940s before being backfilled and subsequently uncovered during downsizing activities in 1993. Excavation of the turntable led to the discovery of an underground storage tank (UST) which held 30 gallons of oil containing 231 milligrams per liter (mg/l) of polychlorinated biphenyls (PCBs). The tank, its contents, and the smaller turntable were removed and disposed of offsite by RF&P in 1994 (*ETI*, 1995).

The refueling area consisted of a minimum of eight underground storage tanks (USTs) located in and around the Central Operations Area, four large 25,000-gallon ASTs, and one smaller AST of approximately 10,000 to 15,000 gallons. All the USTs and ASTs were removed by RF&P as a part of the CERCLA and VDEQ remedial activities discussed in Section 5.0.
